# APPLICATION STORY

## MOBILE THERMOGRAPHIC MONITORING OF BELT CONVEYORS HELPS AVOID FIRES

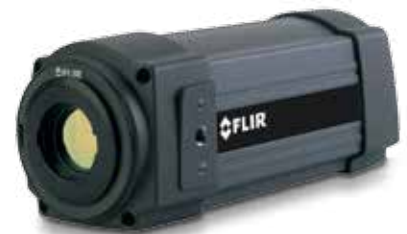
The FLIR A310 thermal imaging camera

(www.inau.de). He suggested trying a permanently installed thermal imaging camera from the FLIR A series. The FLIR A310 was mounted on the bed of an SUV and pointed in about a 45-degree angle to the direction of travel. Among other things, a special housing unit was required to securely mount the FLIR A310. The thermographic camera system can operate without any cable connection, because it includes a battery power supply and a wireless communication unit.

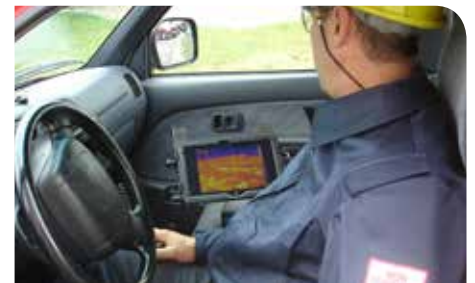
Monitoring with the tablet PC

Klaus Flocke recommended a wide-angle lens to cover as much of the conveyor belts as possible while passing by. The A310 transmits the camera image via Wi-Fi to a tablet PC installed in the driver's cab. If a preset alarm temperature is detected, this tablet PC emits an acoustic warning signal. Only then the driver (who otherwise focusses entirely on driving about 20 km/h at a distance of 2-15 meters away from the conveyor belts) checks the image on the monitor and locates the overheated section of rollers on the conveyor belts.

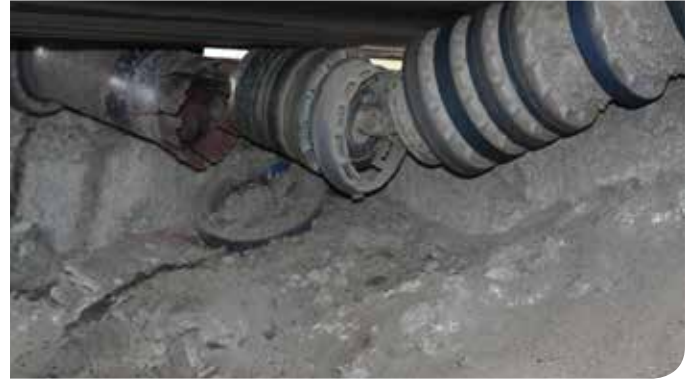
Defective lower support roller of a belt conveyor

At its strip mines, MIBRAG operates approximately 70 km of belt conveyors, which include steel rollers and idlers with rubber or polyurethane support rings. Wear on the bearings can cause overheating, which can ignite the lubricants and support rings of the lower rollers. Even the upper steel rollers can heat up to the point that the steel starts to glow. Especially when a belt conveyor is at a standstill, a large fire hazard can arise after just 10 to 15 minutes.

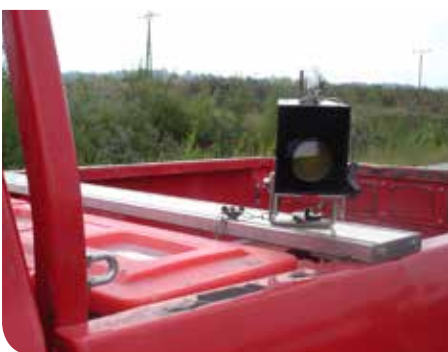
The FLIR A310 was mounted on the pick-up in a special protective housing
