FLIR ARMS INTELLIGENT POWER INSPECTION ROBOT WITH "HOT EYE"

APPLICATION STORY

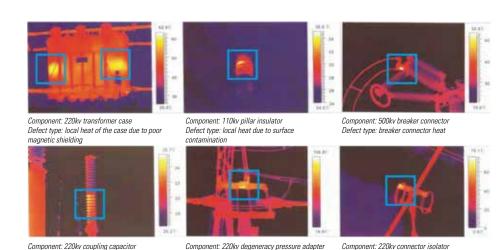
Defect type: heat due to poor connector connection

at pressure pipe

Defect type: heat due to dielectric loss of the

Defect type: heat due to poor connection at ring
