FLIR thermal imaging cameras help determine road conditions in Finland

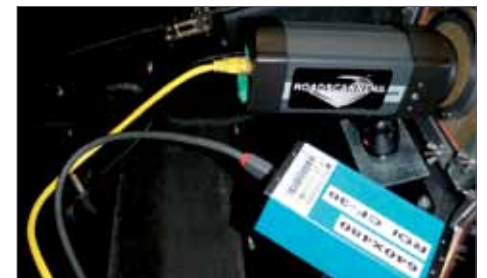
The Road Doctor diagnostics top box contains both a FLIR A-Series thermal imaging camera and a digital video camera.

The thermal imaging camera is mounted on top of the Roadscanners' diagnostic vehicle. Currently FLIR A315 thermal imaging cameras are being used, but a switch to the FLIR A615 is being considered.

To be able to cover the entire road, a wide angle lens with 90° Field of View (FoV) is used. The data collected by the visible light camera, the Ground Penetrating Radar (GPR) and the thermal imaging camera are combined and stamped with the GPS location to enable accurate mapping of the problem areas that will need repair.

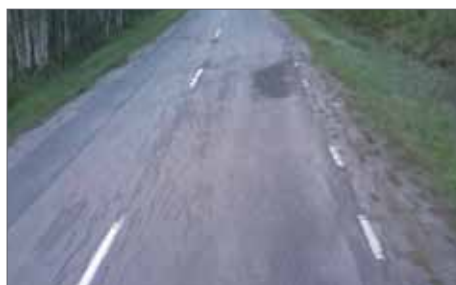
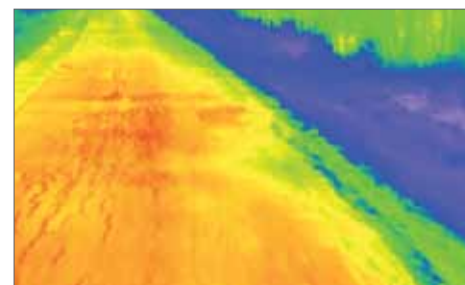
Thermal images taken in late spring are extremely valuable for road repair teams, because they show the location of the thawing ice in the underlying road structure.

"With a thermal imaging camera from FLIR you can find water ingress in the road surface that is invisible to the human eye", explains Saarenketo. "If water has entered the road structure it changes the way the road heats up or cools down. So in the dusk hours of the morning and evening the patches of road that contain water will show up in the thermal image. This information can be used to predict when that section of road will need repair. And the same concept also applies to bridges, where good water insulation is crucial for the lifetime of the concrete deck."
